Arkwood, Inc.
Omaha, Arkansas

DOCUMENTATION RECORDS
FOR
HAZARD RANKING SYSTEM

POTENTIAL HAZARDOUS WASTE SITE
SITE INSPECTION REPORT

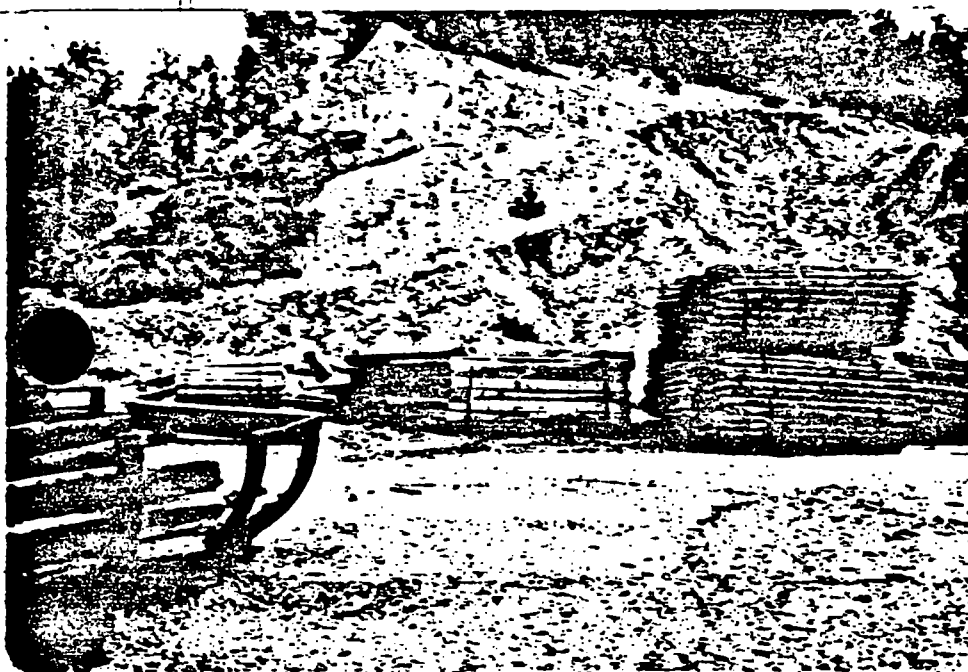
SUBJECT: Soil of hillside - dowl chest
 LOCATION: Southern portion of Arkwood near
County Road, looking SE
 CITY: Cricket COUNTY: Boone STATE: AR
 DATE: Oct. 5, 1981 TIME: _____
 WEATHER: [SUN] [HAZE] [CLOUDY] [RAIN] [SNOW]
 PHOTOGRAPHER (Sig.): Mike Butler
 WITNESS: _____
 CAMERA: Minolta 7s 35mm
 FILM TYPE: Kodakolor ASA 400 T: 1/A f: A
 NEGATIVE LOCATION: ADPC+E FILE #: _____
 PROCESSED BY: Kolor Print
 PHOTO #: 8 of 19

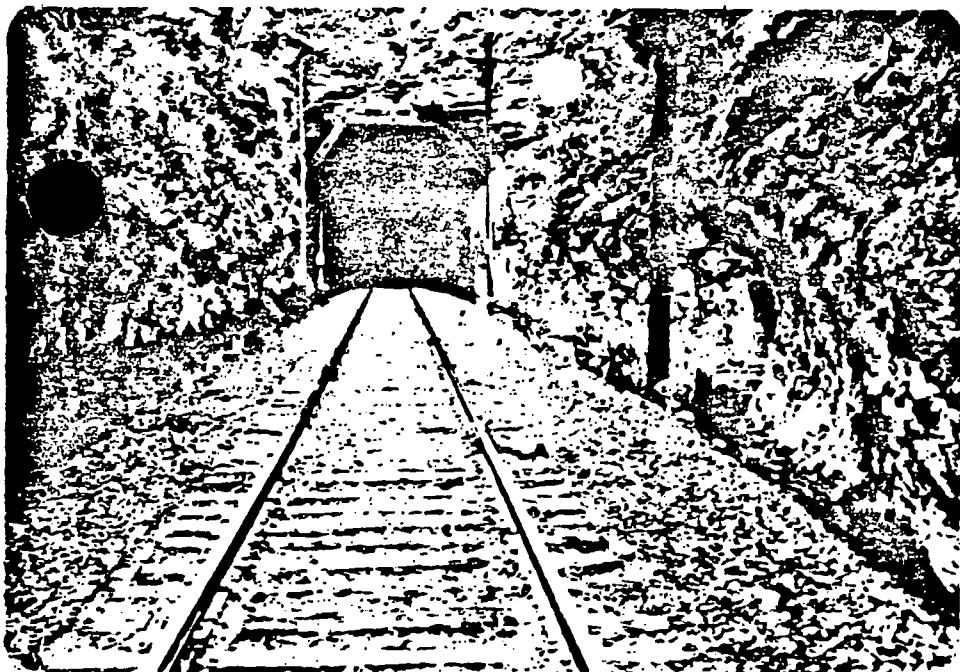
SUBJECT: Southeast entrance to RR tunnel
 LOCATION: Adjacent to Arkwood (Note: disconnection of ditches + water) looking NE
 CITY: Cricket COUNTY: Boone STATE: AR
 DATE: Oct. 6, 1981 TIME: _____
 WEATHER: (SUN) (HAZE) (~~CLOUDY~~) (RAIN) (SNOW)
 PHOTOGRAPHER (Sig.): Mike Butler
 WITNESS: _____
 CAMERA: Minolta 7s 35mm
 FILM TYPE: Kodacolor ASA: 400 T: 1/125 f: Auto
 NEGATIVE LOCATION: ADPct 5 FILE #: _____
 PROCESSED BY: Kolor Print
 PHOTO #: 10 of 19

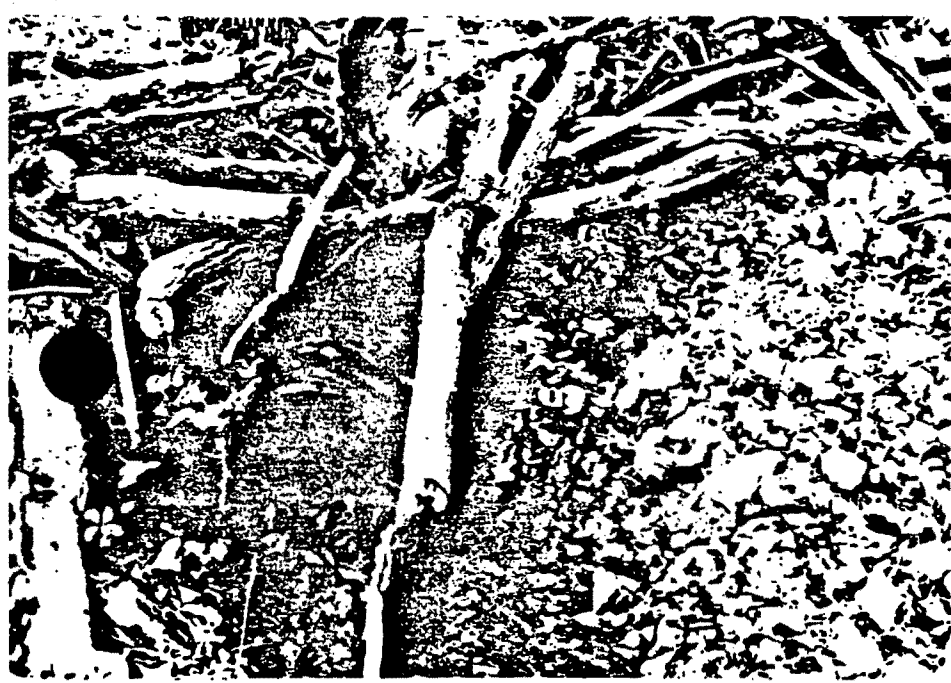
SUBJECT: Truck up stream of sample pt. # 5 (A-S)
LOCATION: dist. discolored water and film
on surface, looking south
CITY: Crocket COUNTY: Burns STATE: AR
DATE: Oct. 6, 1981 TIME: _____
WEATHER: [SUN] [HAZE] [CLOUDY] [RAIN] [SNOW]
PHOTOGRAPHER (Sig.) Mike Bates
WITNESS: _____
CAMERA: Minolta 7s 35mm
FILM TYPE: Kodacolor ASA: 400 T: 1/Auto f: Auto
NEGATIVE LOCATION: ADPCE FILE #: _____
PROCESSED BY: Kolor-Print
PHOTO #: 17 of 19

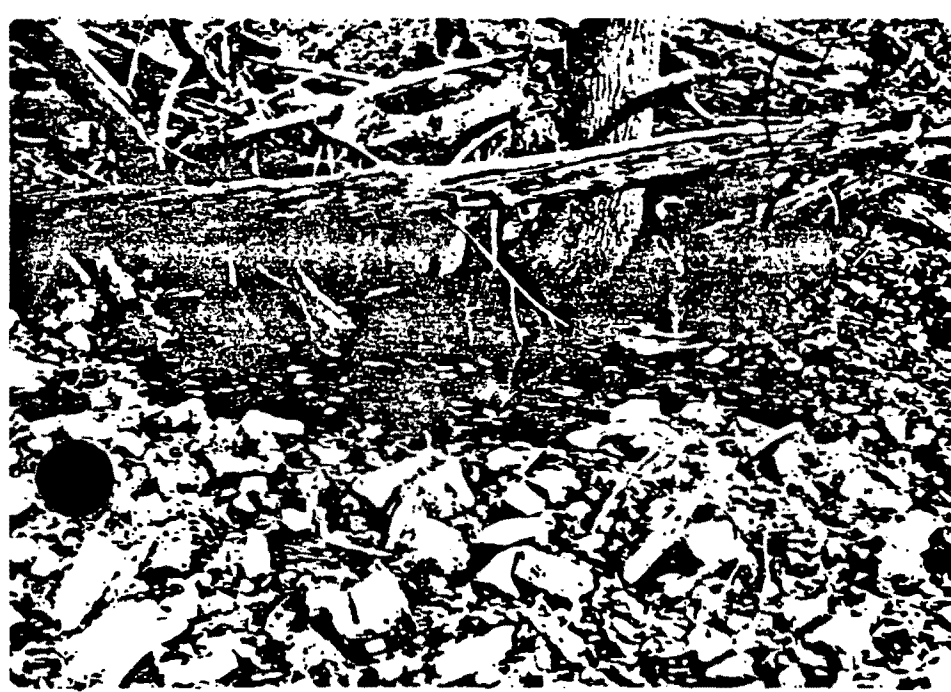
SUBJECT: Sample pt. # 5 (A-S) - Walnut Creek
LOCATION: looking north
CITY: Crocket COUNTY: Burns STATE: AR
DATE: Oct. 6, 1981 TIME: _____
WEATHER: [SUN] [HAZE] [CLOUDY] [RAIN] [SNOW]
PHOTOGRAPHER (Sig.) Mike Bates
WITNESS: _____
CAMERA: Minolta 7s 35mm
FILM TYPE: Kodacolor ASA: 400 T: 1/Auto f: Auto
NEGATIVE LOCATION: ADPCE FILE #: _____
PROCESSED BY: Kolor-Print
PHOTO #: 18 of 19

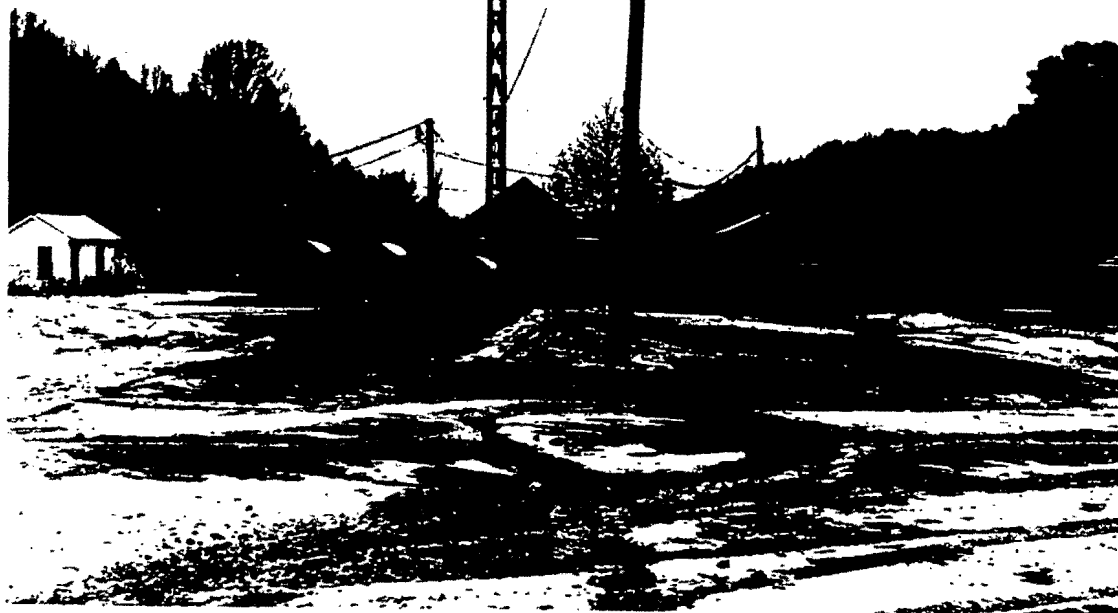
③

DRIP PAD MADE OF

CONCRETE. (FORE GROUND)

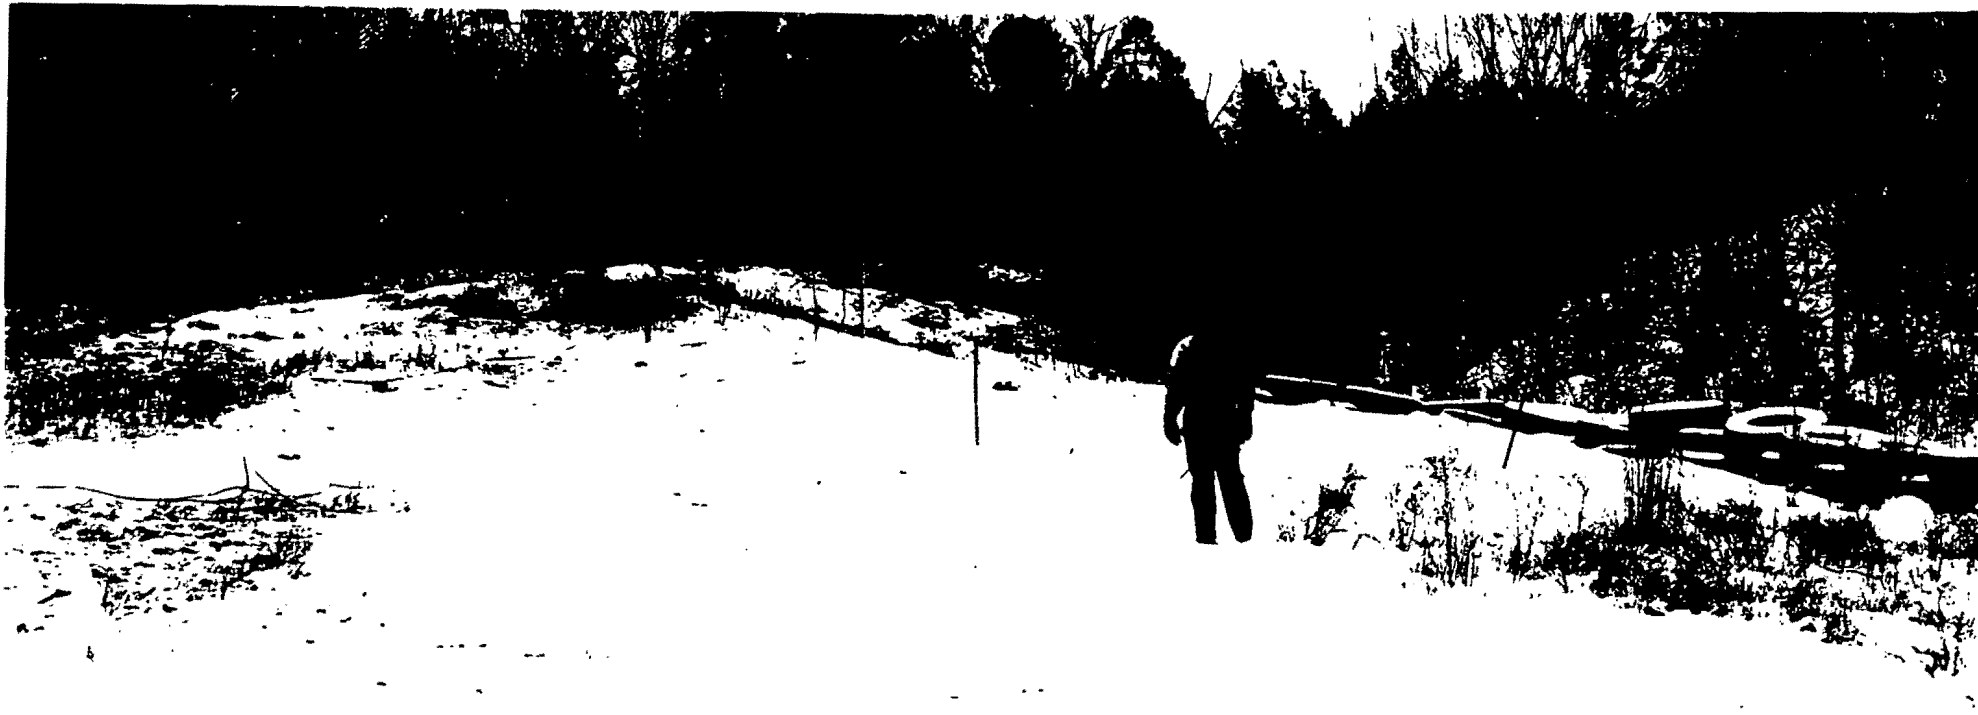
5 + 6

18 yds³ NO CHEMICALS

WERE PUT ON THE PILE.

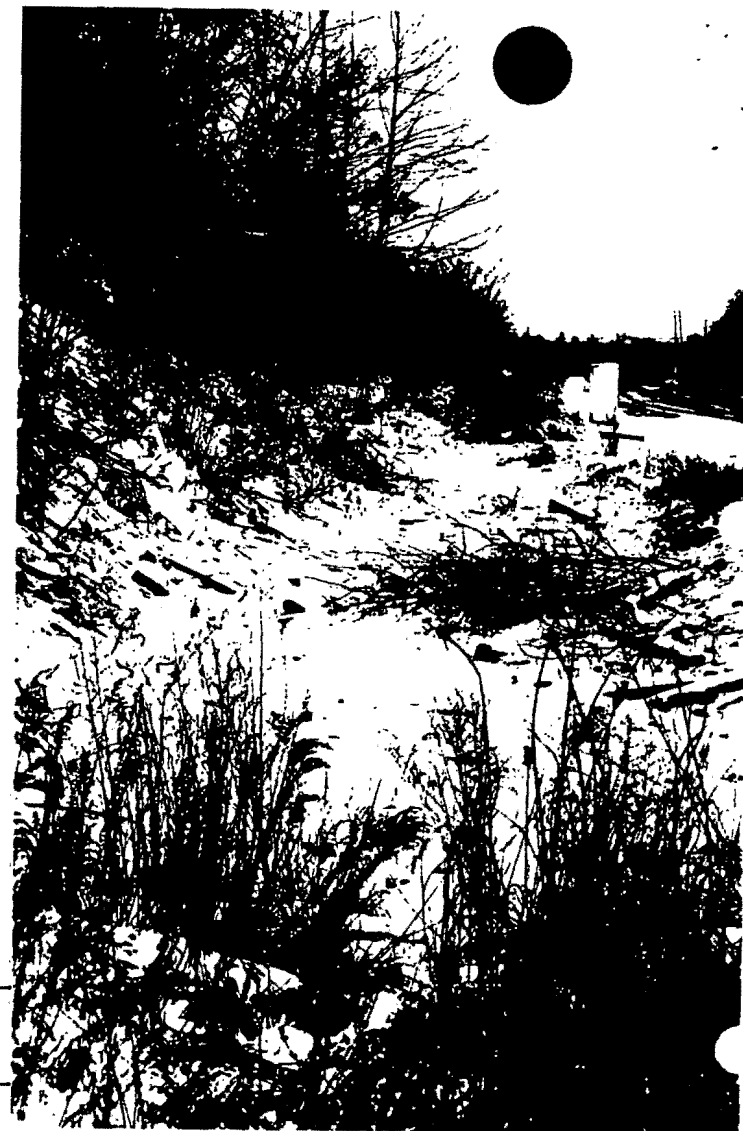
(11)

The pit, located on the railroad property north of the site, is empty (see attached photos and site sketch). Mr. Barker explained that the pit had been used to burn waste materials, using old rubber tires to start and sustain the burning. That practice was stopped in the mid to late 1970's when the firm started to recycle most of their by-products. The pit is currently empty and is ill defined since it has not been used for some time. The approximate dimensions of the pit are; 60 ft. (length) x 15 ft. (width) x 3 ft. (depth).

AND RUBBER TIRES

(PIT - 60 FT (L) X 15 FT (W) X 3 FT (D))

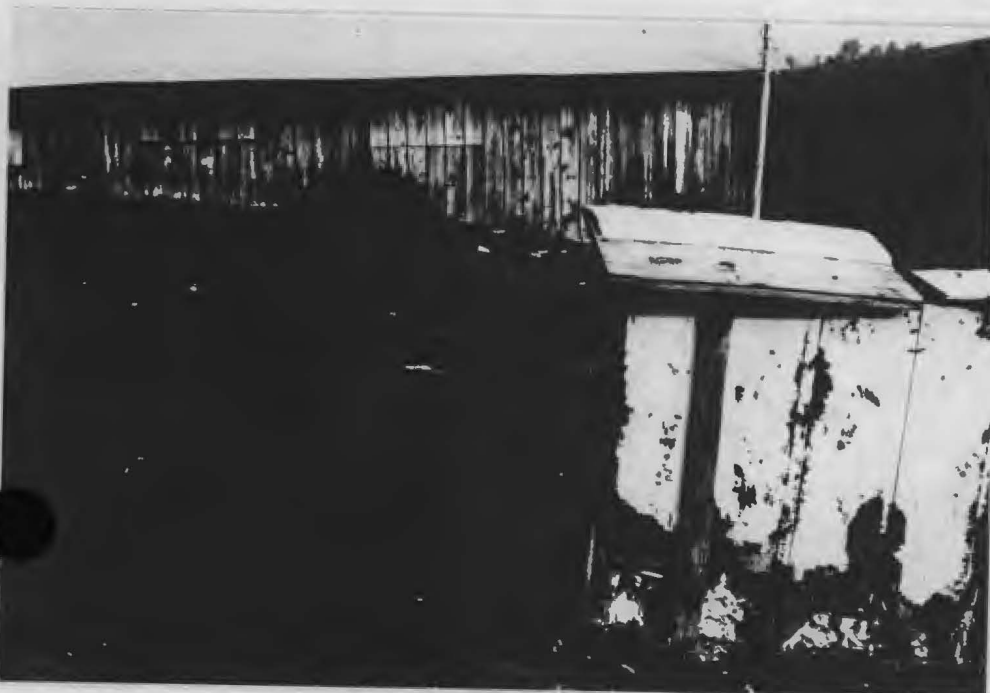
dismantled well

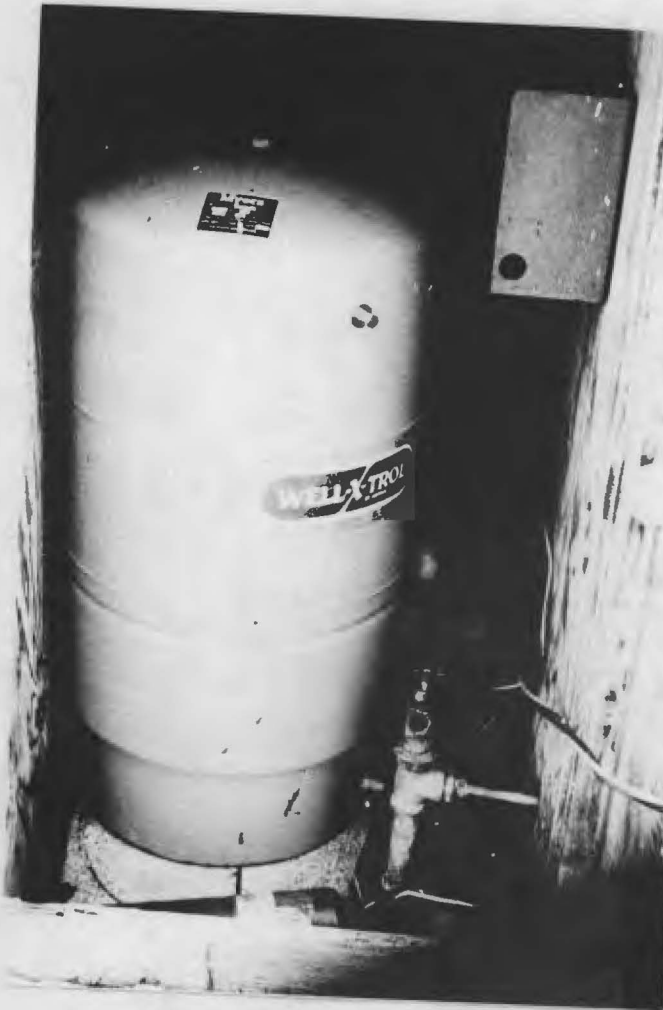
Comments: Inside of

Bahren's dismantled
well
